**Hex-Chrome Free Sealant Project Phase II with
Beachfront Test Vehicle Addendum**

MPLR – 101562A
January 13, 2015

T.R. # 101562
Lockheed Martin Corporate Project

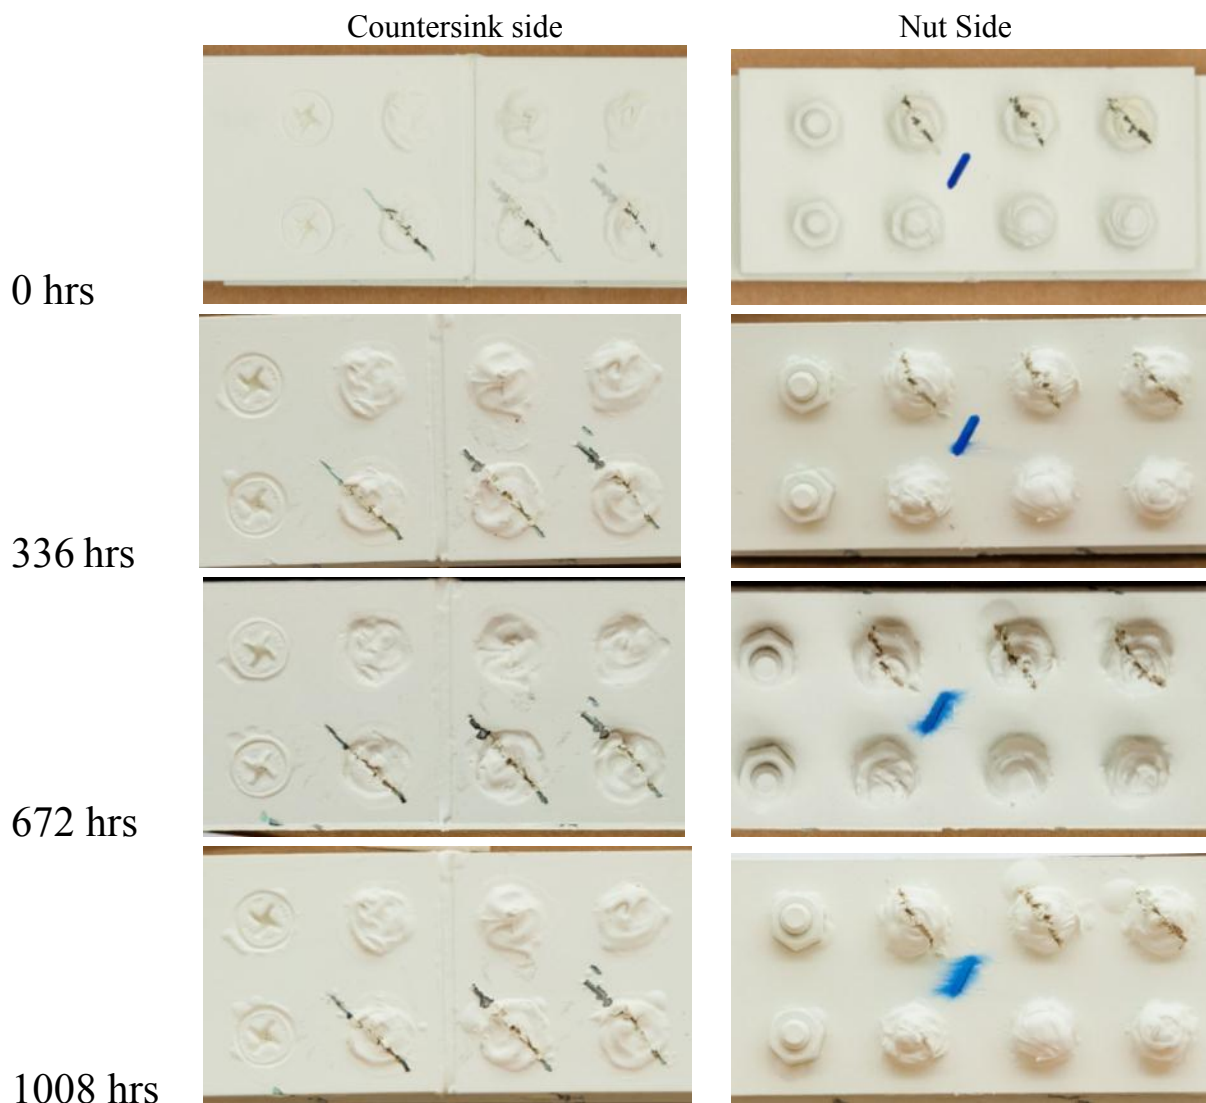
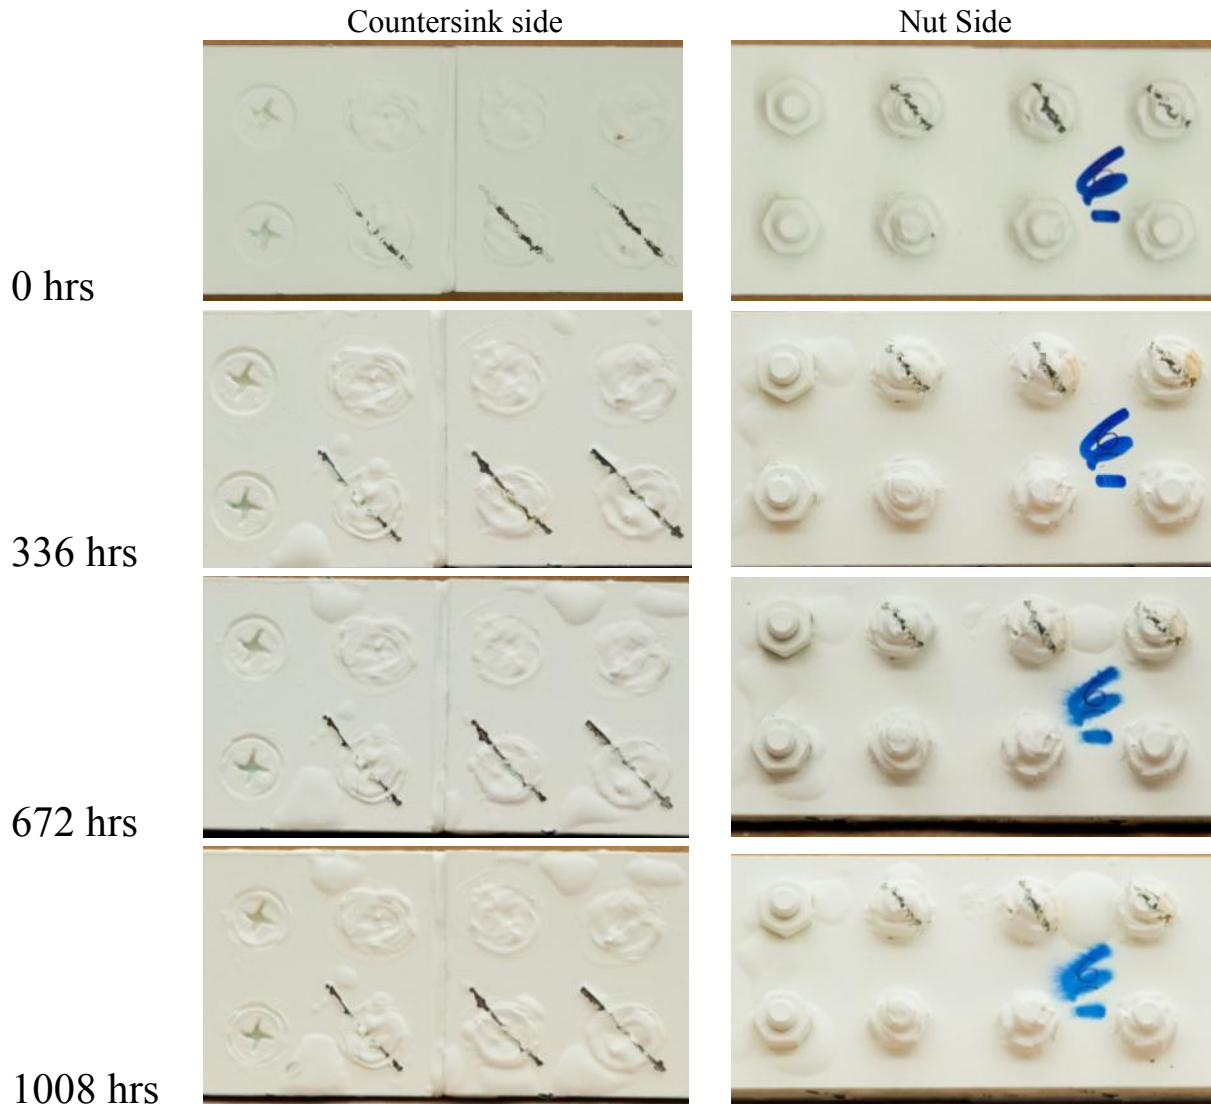
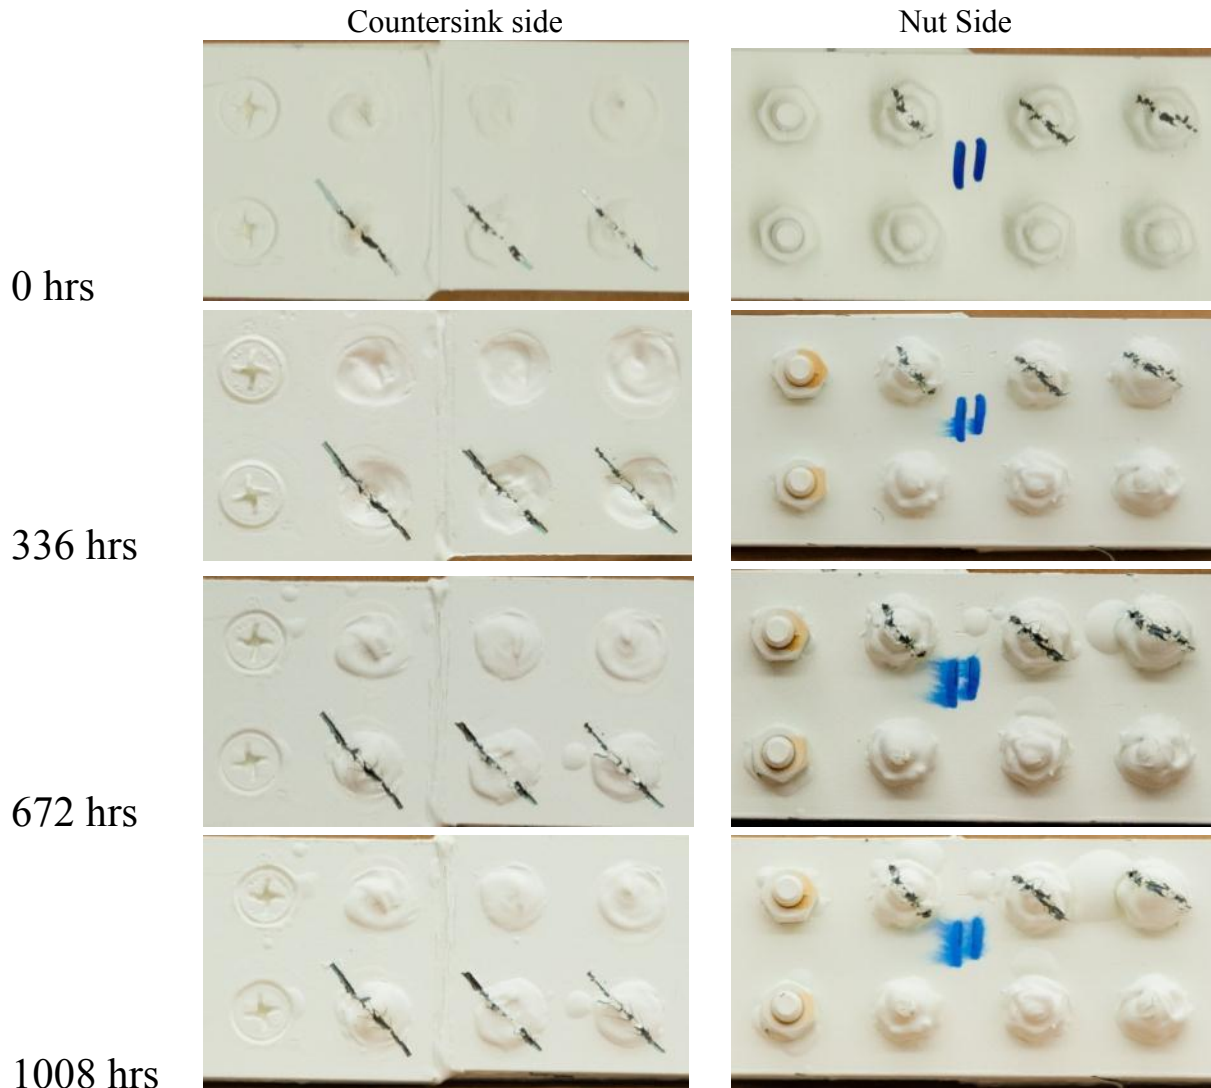
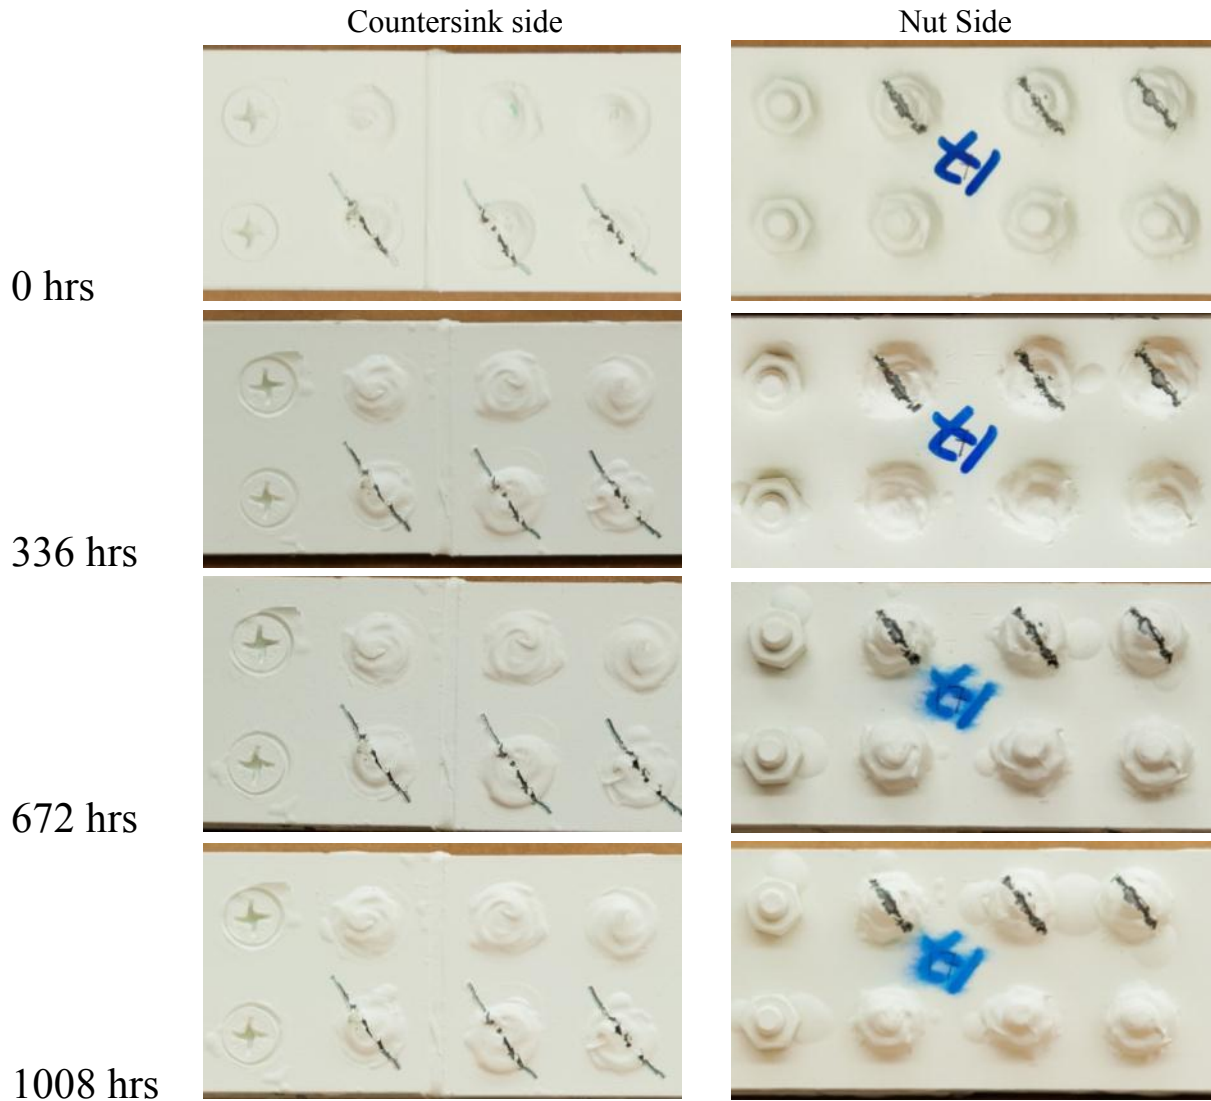
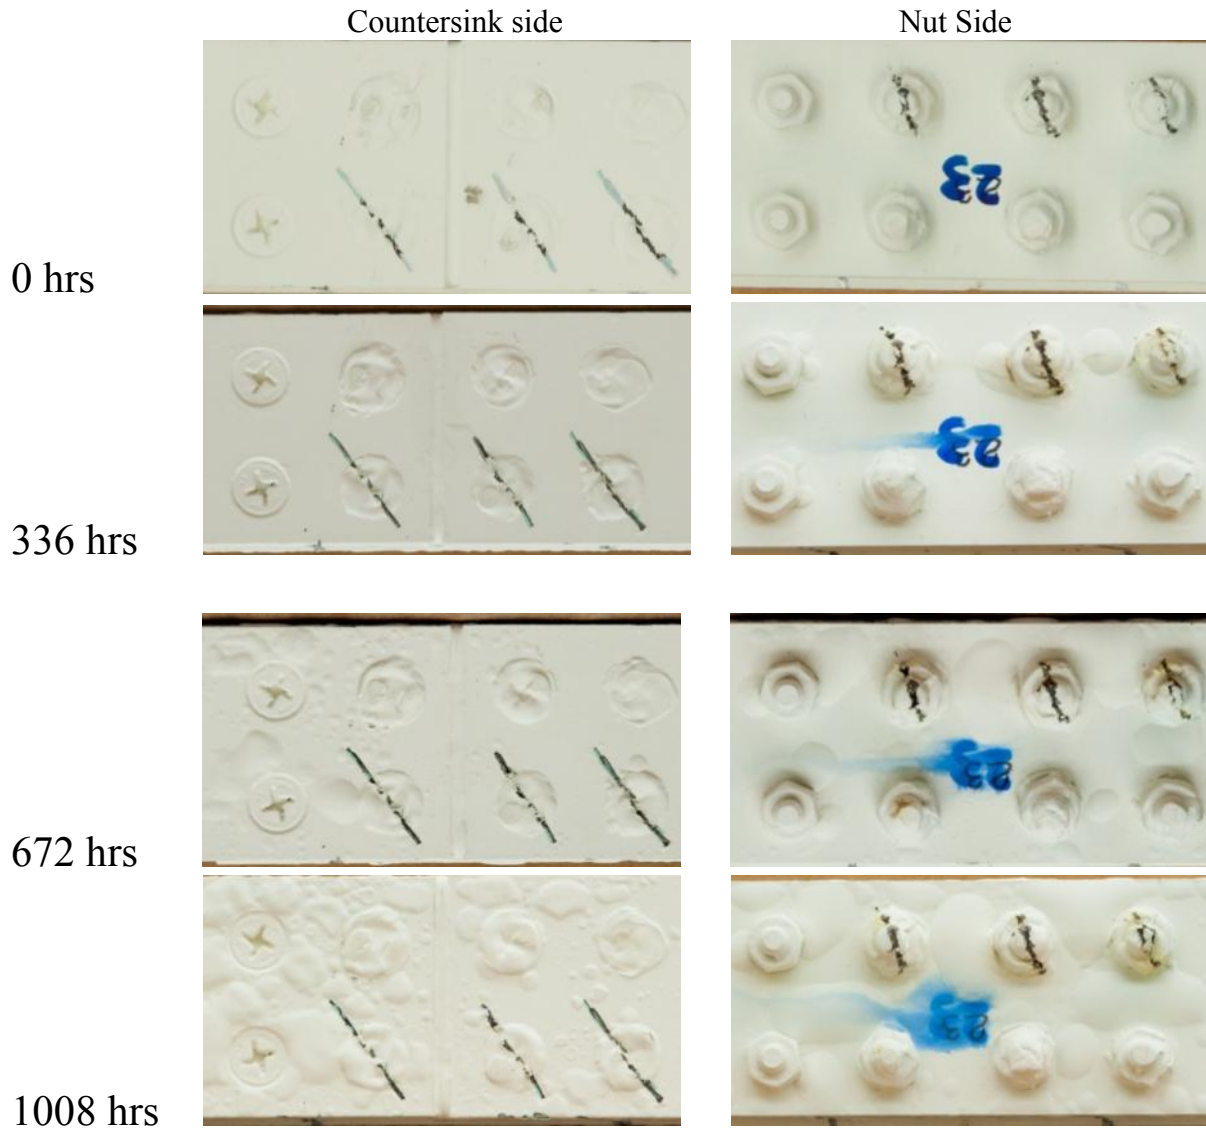
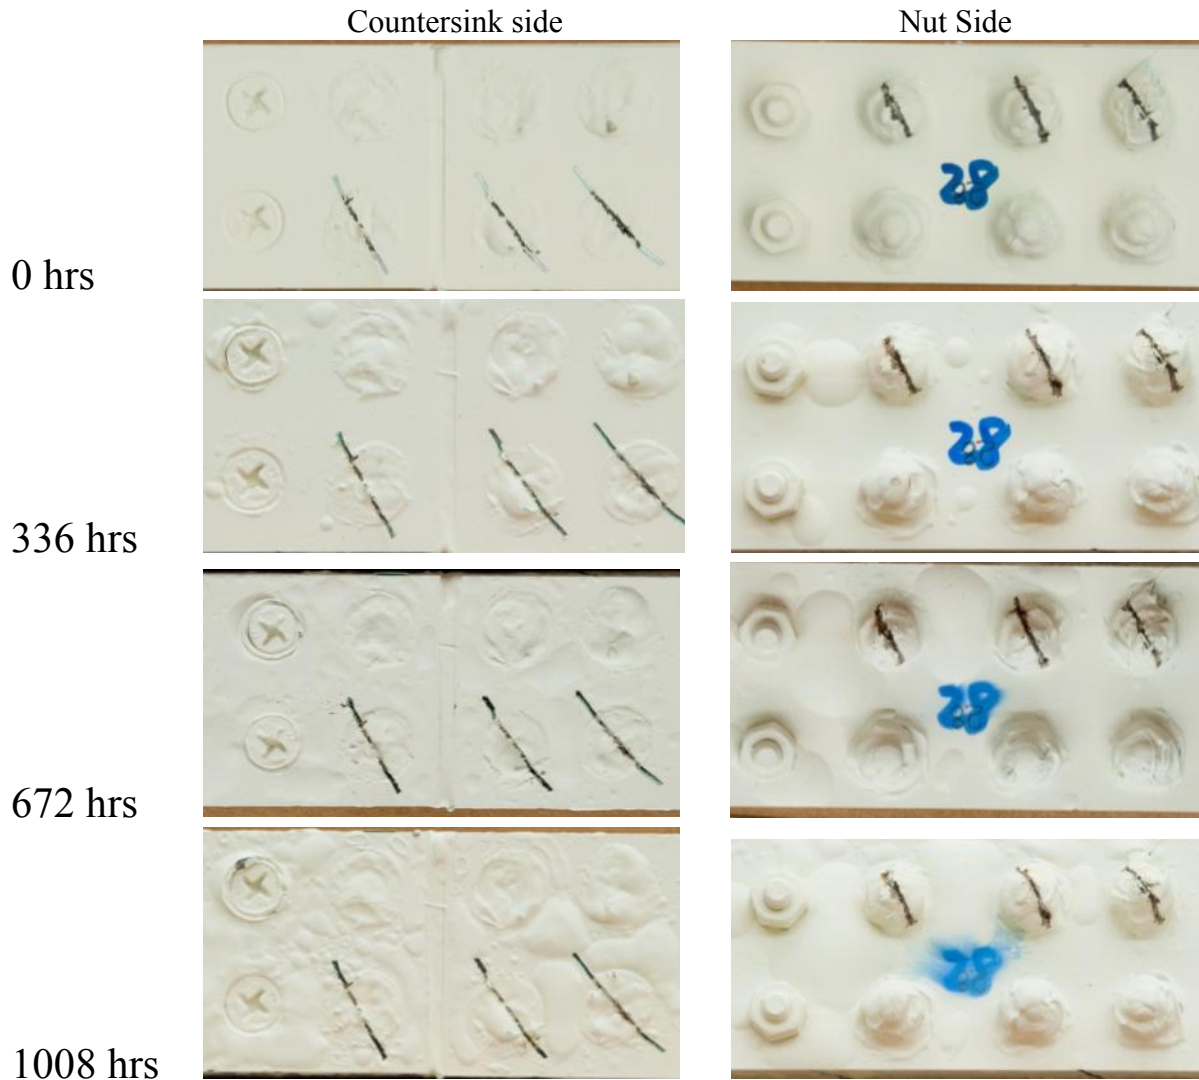
One aspect of corrosion that could be observed, as seen in Figures 8.1.1 through 8.1.6, is the test vehicles' blistering through the exposure process, causing what is believed to be corrosion beneath the primer/topcoat. The control test vehicle, as well as the AC-735, PR-1775, and RW-6040-71, all blistered at roughly the same rate through the exposure. The FM CS5500N CI and PR-1440, however, blistered at an accelerated rate.

From both the mechanical stress and SO₂ salt fog exposure, several leak paths, which caused corrosion within the butt joint and countersink areas, were formed, as seen through cracking and blistering of the primer/topcoat. After the 1008 hour inspection, several cracks were observed through the sealant in the butt joint of many of the coupons. The cracks around the countersink areas were a result of the scribes through the sealant overcoat, and possibly due to the blistering phenomenon issue. The fastener heads that were scribed and overcoated with sealant showed corrosion due to the existing presence of such leak paths. Fasteners that were overcoated with sealant and not scribed appeared to have less damage, although some blisters appeared around the fasteners.

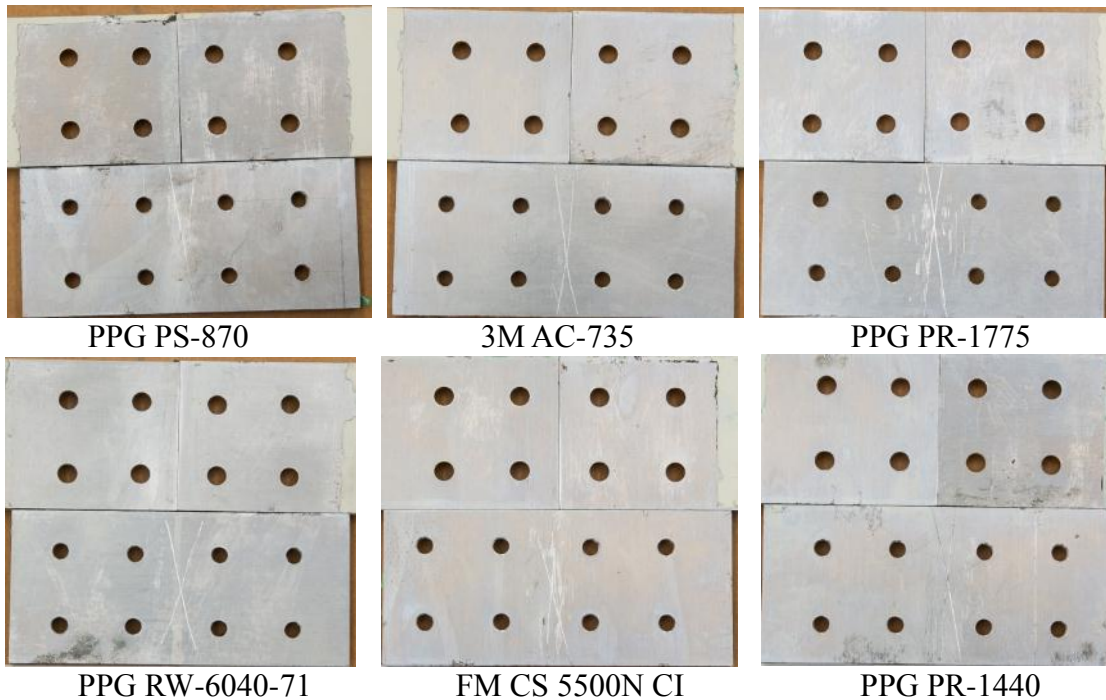
FIGURE 8.2.1 FAYING SURFACES OF TEST VEHICLES AFTER DESTRUCTION

Despite the cracks and corrosion to the butt joint sides, the faying surfaces experienced minimal total area of corrosion. Within the faying surface, AC-735 performed the best at 1.1% total area corrosion, while the other sealants, excluding the negative control, performed about the same at around 3% total area corrosion. PR-1440 had corrosion on an average of 5.2% of each faying surface. The corrosion on the faying surfaces came from the initiated damage done by the scribes on the sides of the test vehicles.

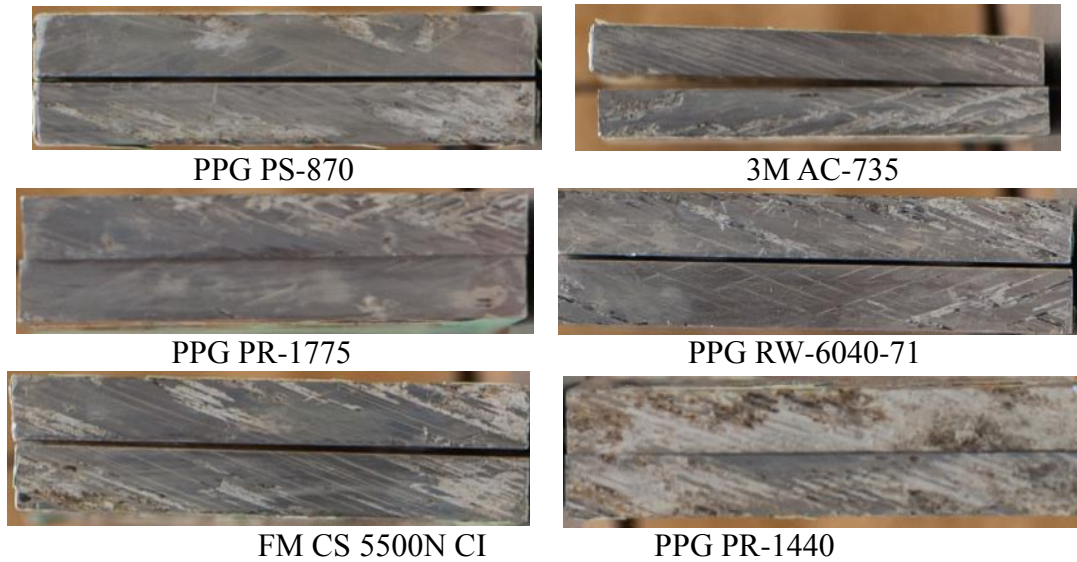
FIGURE 8.2.2 BUTT JOINTS OF TEST VEHICLES AFTER DESTRUCTION

For the butt joint area, PR-1775 performed the best out of all the sealants corroding on an average of only 2.8% area within each test vehicles butt joint. The PS-870, RW-6040-71, and CS5500N CI corroded an average of around 6% total area on each butt joint, and AC-735 corroded on average 7.9% in each butt joint. The negative control, PR-1440, performed the worst by allowing 10.8% area corrosion on each test vehicle. Some of this corrosion came from cracking in the butt joint, both on the top of the joint and from the sides, while some came from blisters on the surface.

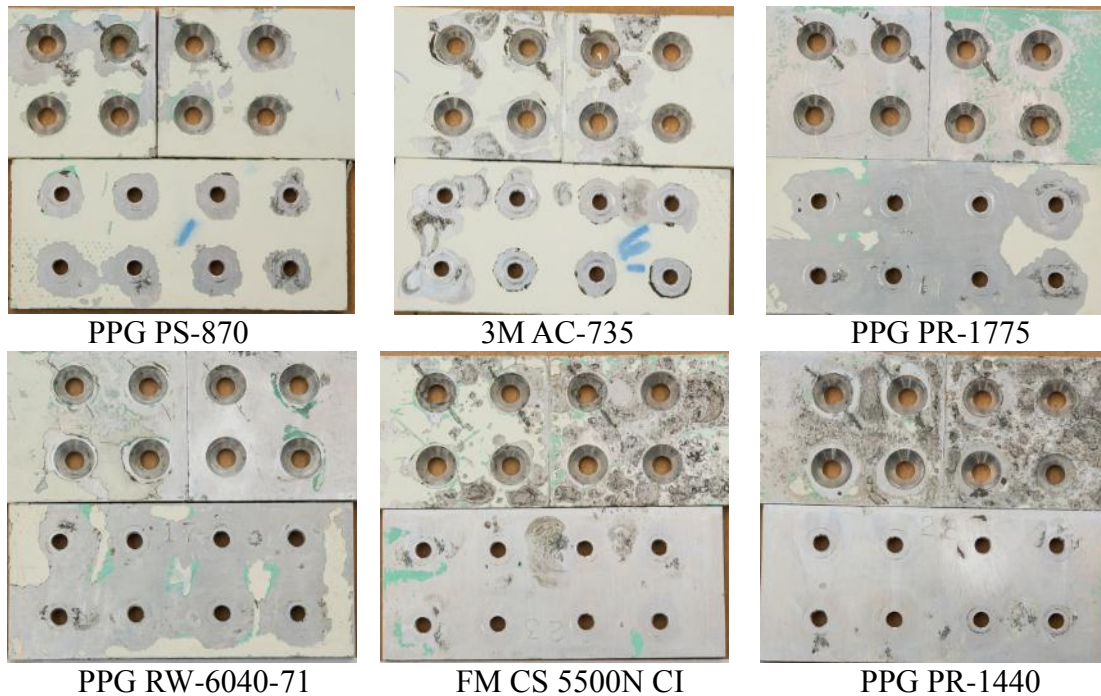
FIGURE 8.2.3 COUNTERSINK HOLES AND BARREL HOLES OF TEST VEHICLES AFTER DESTRUCTION

In the Countersink and Fastener Hole Areas a few trends emerged during the destructive inspection. The fastener heads overcoated with sealant and not scribed provided sufficient corrosion resistance for a majority of the sealants, with only 0.1% area corrosion. FM CS5500N CI and PR 1440 were less protected because of the primer/topcoat blistering phenomenon.

The fasteners overcoated with sealant and scribed demonstrated that PR-1775, CS5500N CI, and PR-1440 were as good as PS-870 at preventing moisture from attacking the countersink areas when damage was initiated, with corrosion occurring on 10% of the countersink and barrel areas. The AC-735 and RW-6040-71 did not provide as much corrosion resistance with roughly 13% corrosion.

For the fasteners that relied purely on wet installation for corrosion protection, PS-870 performed the best at 2.3% total area corrosion, with PR-1775 performing closest at 3.5% countersink area corrosion. The CS 5500N CI, AC 735, and RW-6040-71 each had about 8.5% of the countersink areas corroded, and PR-1440 had 15.1% area corrosion.

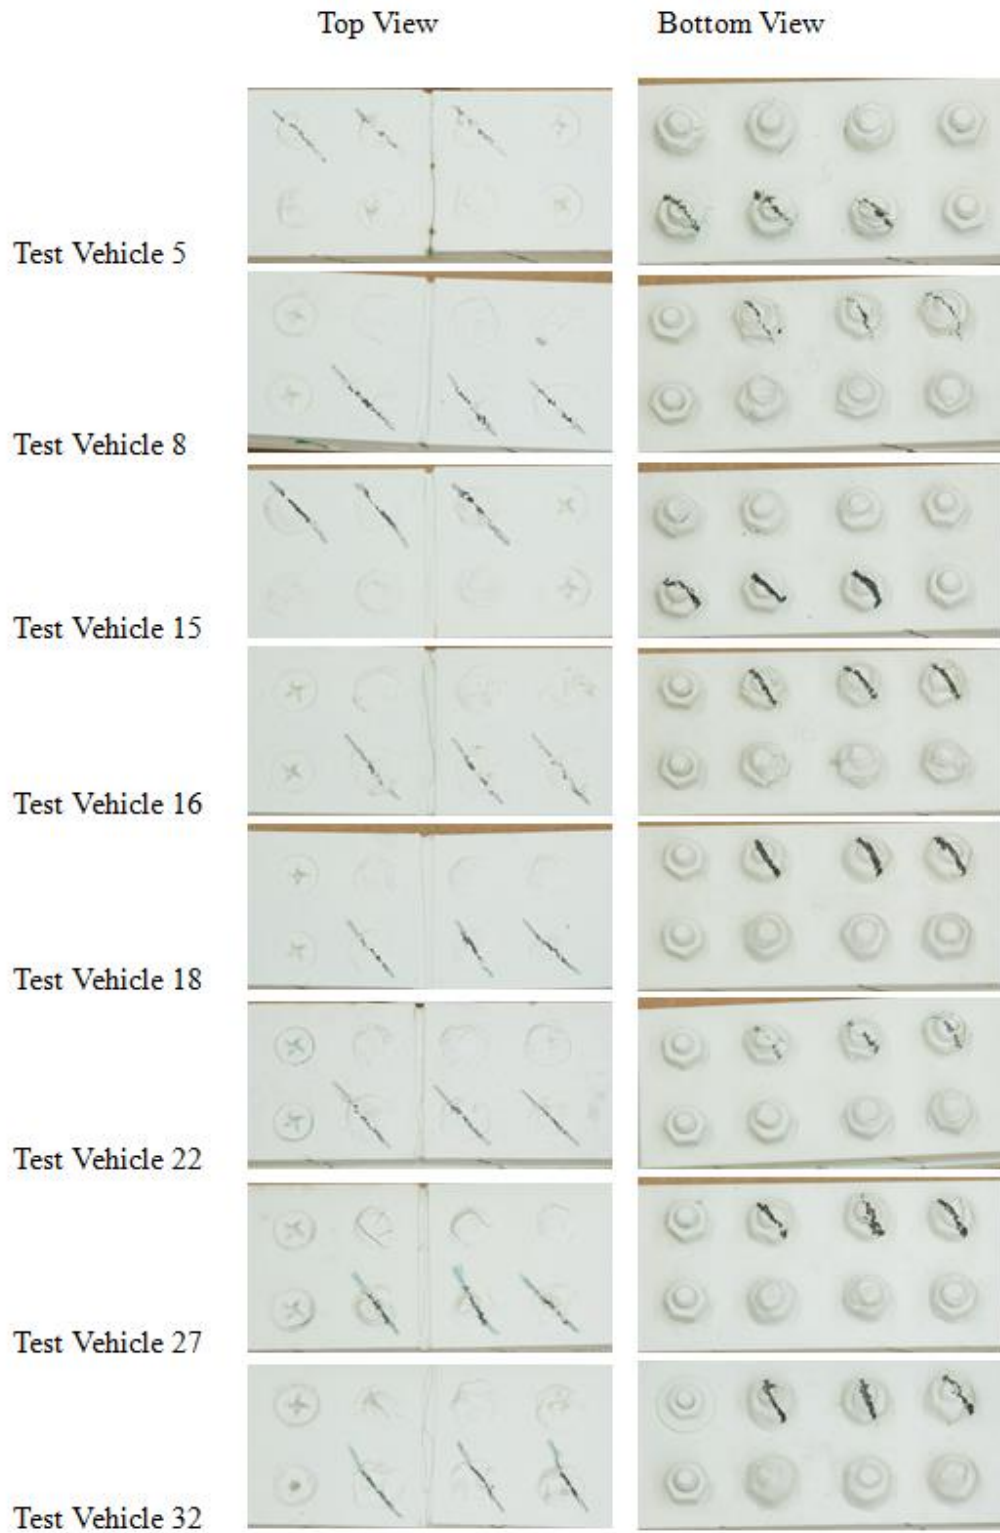
FIGURE A1. NONDESTRUCTIVE VIEWS

The nondestructive evaluation of the test vehicles were done similar to MPLR-101562 Paragraph 7.4, by providing exterior surface corrosion observations. The beachfront exposure, since it is not as harsh of an environment as the SO₂ salt fog exposure, damaged the test vehicles much less on the external surfaces. The only location corrosion could be seen during the nondestructive evaluation was the areas around the fasteners that were not overcoated with sealant. Figure A1 shows the top and bottom areas of the test vehicles before they were broken apart.

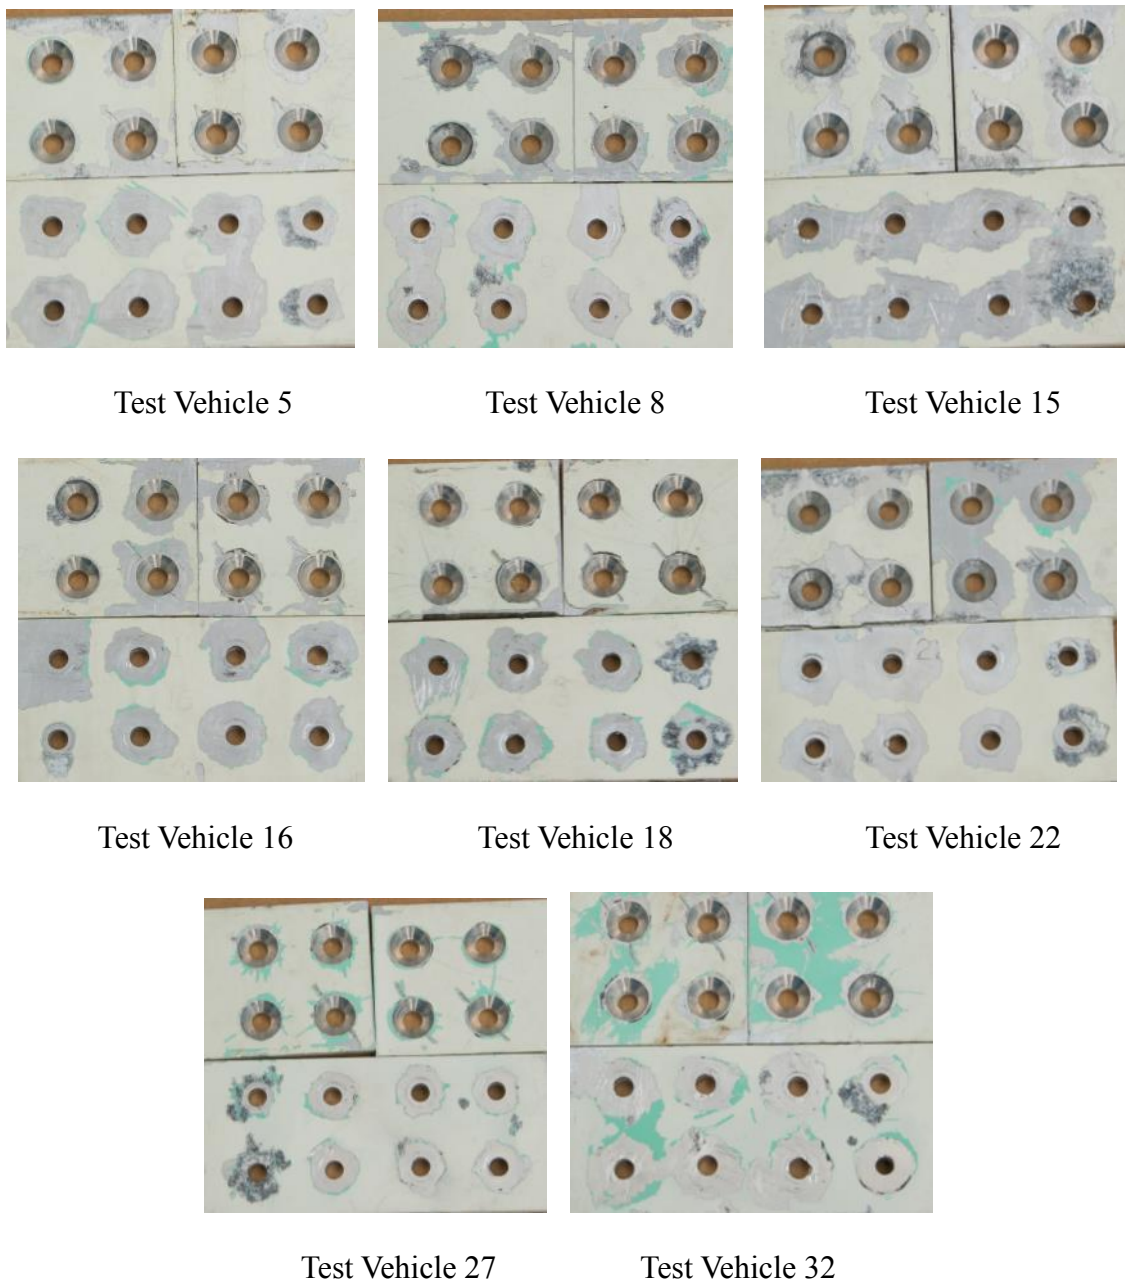
FIGURE A2. DECONSTRUCTED COUNTERSINKS AND NUT AREAS

The test vehicles subjected to beachfront corrosion exposure were disassembled using a pneumatic press and hammer after their arrival at Lockheed Martin. The sealant inside the test vehicle pieces were stripped from the substrate using toluene. Figures A2 through A4 show views of the test vehicles after disassembly. Table A1 shows the % area of corrosion results of the destructive inspection for each area of interest, using the process described in Section 7.6.
