Cleaning Success Stories: Morgan Advanced Materials

TCE Elimination

Morgan Advanced Materials

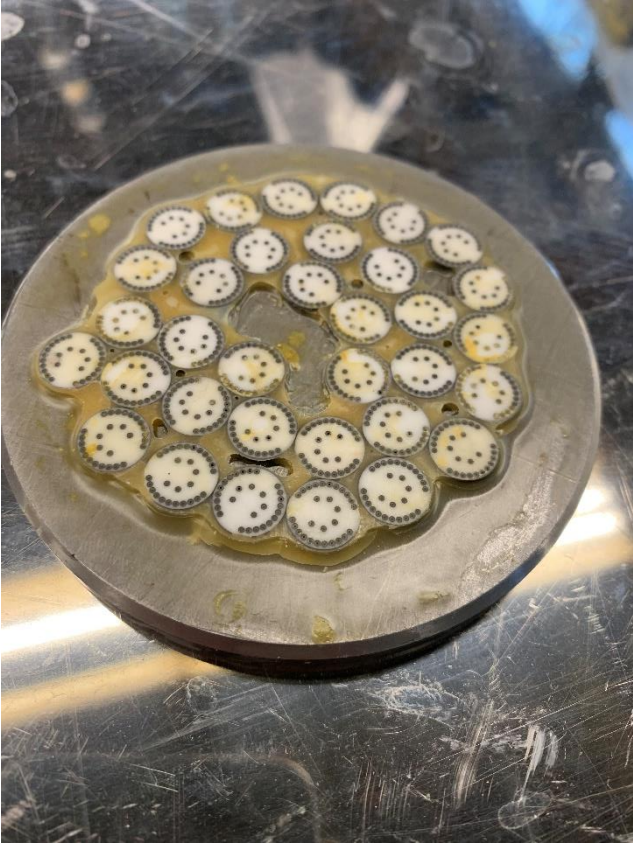
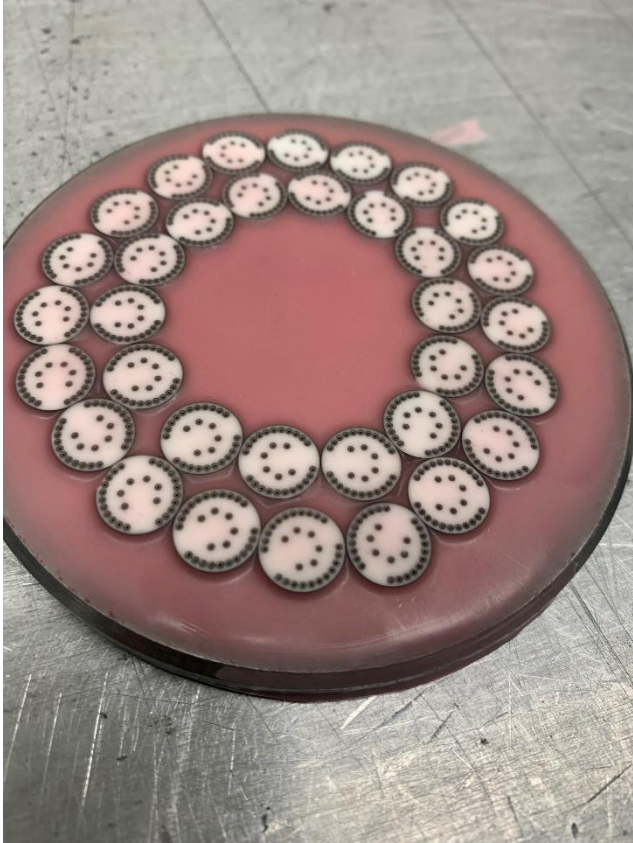
Waxes Used

- Two waxes used
 - Brown Z286 Wax – large/bulky parts
 - Pink casting wax – parts that get ground on both sides and flipped
- Sister company in CA developed water-soluble wax
- Test wax in-house in New Bedford
 - Removed with hot water and borax/baking soda
 - 3 station Crest clean-line
 - Wash – Wash – Rinse
 - Not able to flip parts
- Qualified on Medical implant ceramics only due to concerns

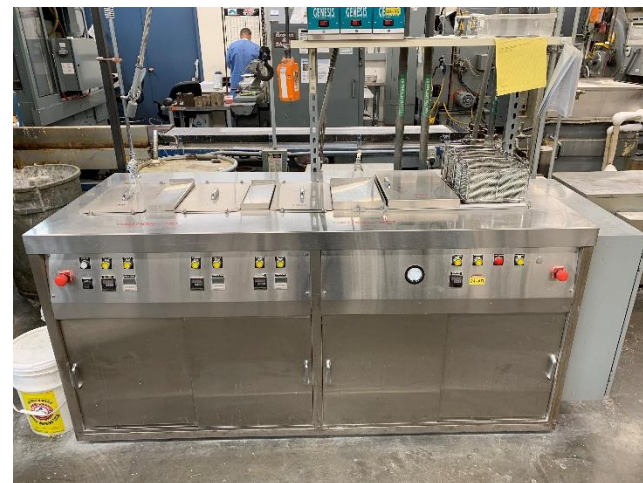
Contaminated Water Tanks

Water tanks
contaminated after
one cycle

No cascade or
overflows

Need to drain and
clean tanks after one
cycle

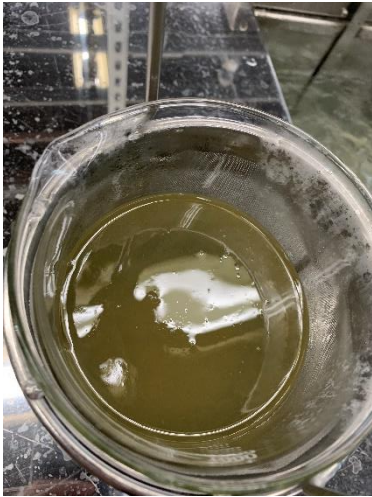
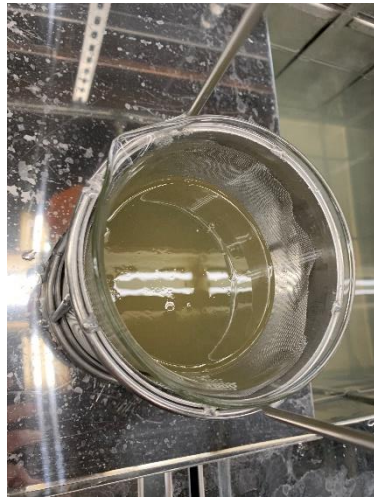
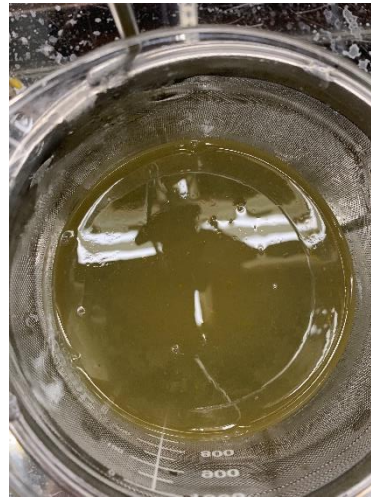
Hayward
Water-Soluble
Wax

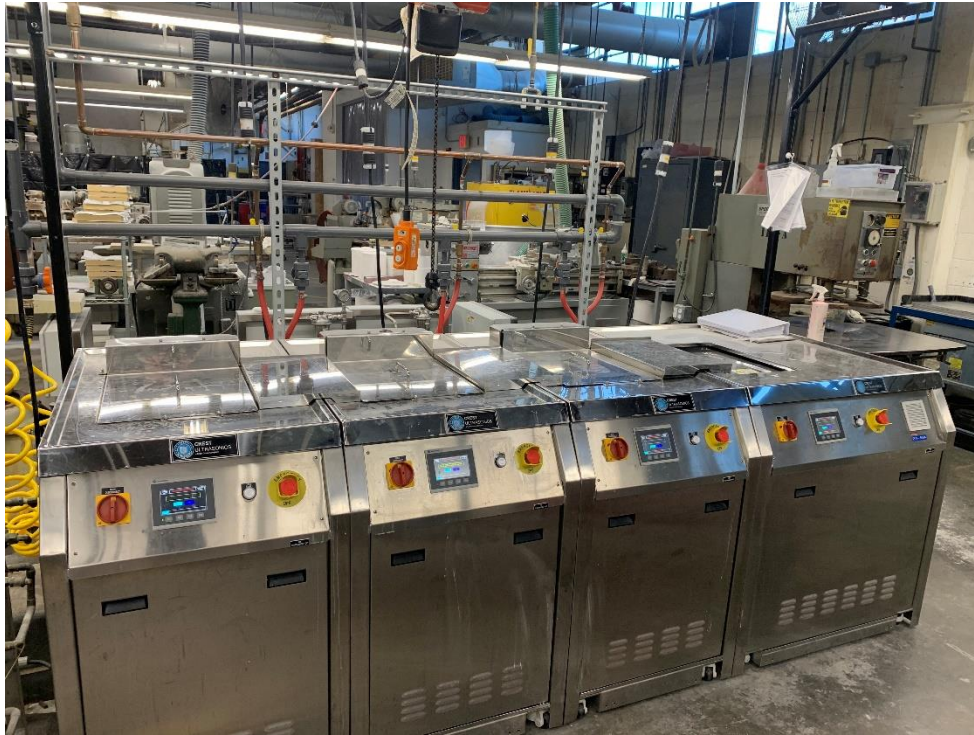
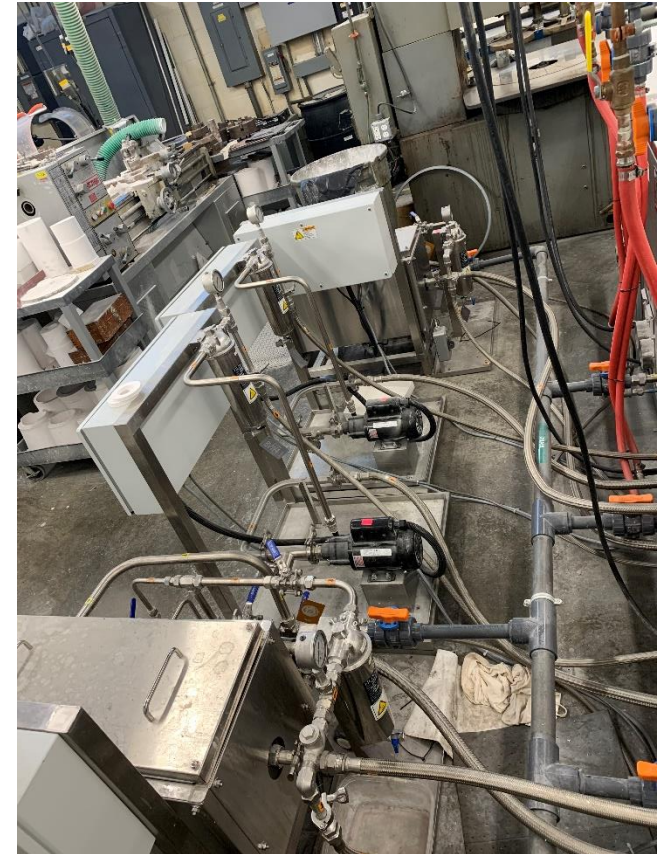
Equipment Selection

Wax Separation Units
