**Hex-Chrome Free Sealant Project Phase II with
Beachfront Test Vehicle Addendum**

MPLR – 101562A
January 13, 2015

T.R. # 101562
Lockheed Martin Corporate Project

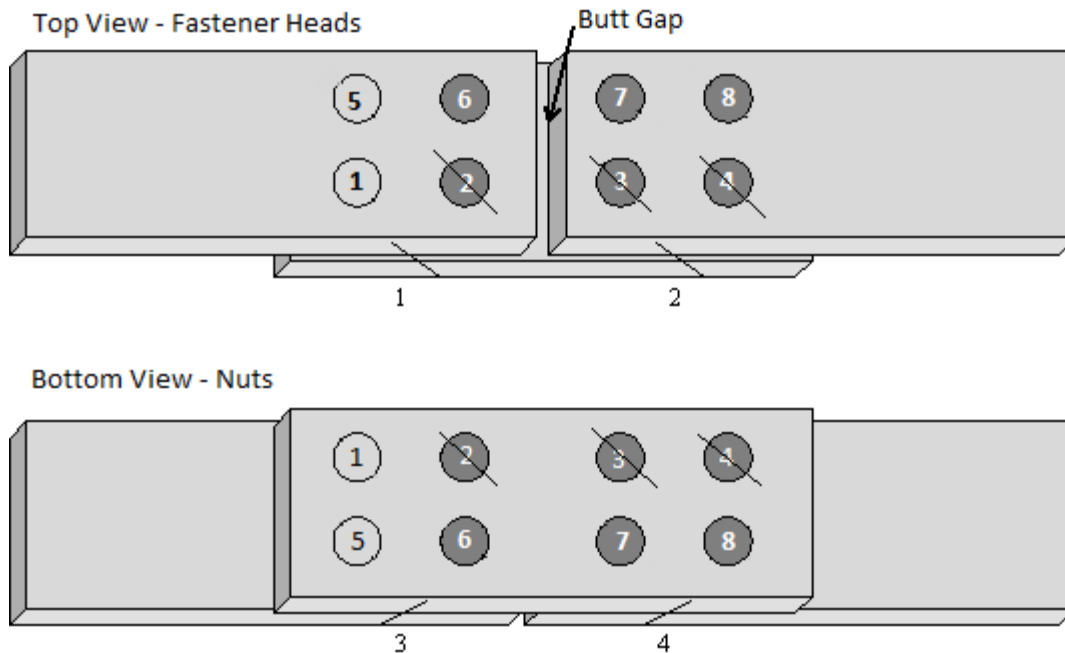
FIGURE 6.4.8 SCRIBED AREAS OF THE TEST VEHICLE

Sikkens Model 463 with a 1 mm wide carbon tip. A scribe through the primer and topcoat at edge of test vehicle in four locations was made. In addition, scribes were applied to three fastener heads and the three corresponding nuts on each test vehicle. The other five fastener heads and five nuts on each test vehicle did not get scribed. The scribed areas are portrayed in Figure 6.4.8. Dark marks denote sealant overcoated areas, and lines indicate a scribe.

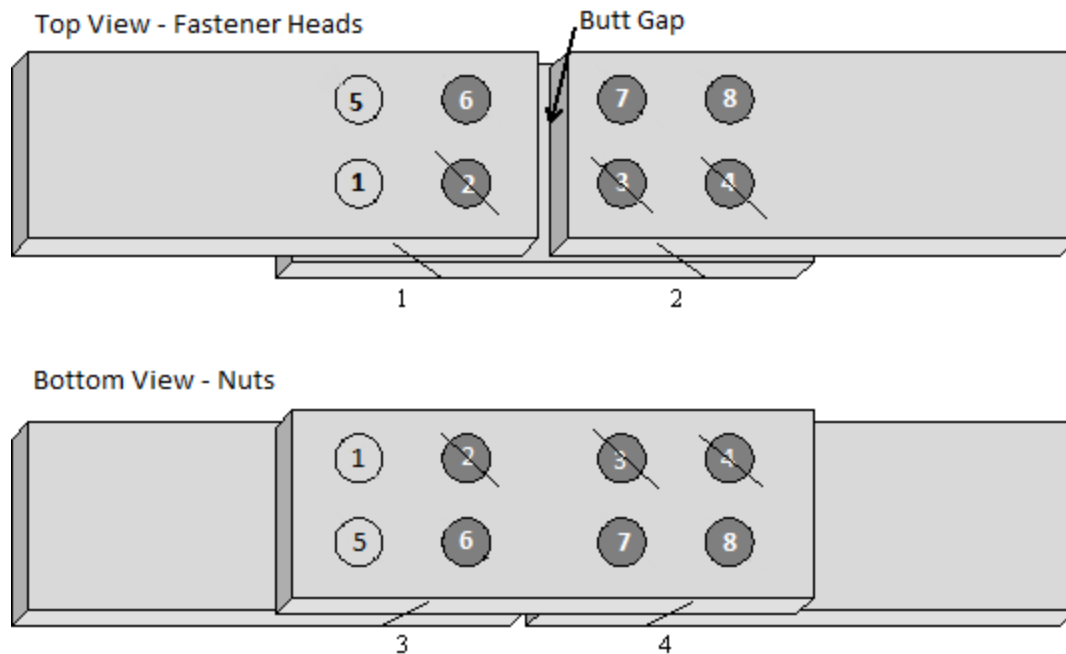
FIGURE 7.4.1 AREAS OF INTEREST FOR NON-DESTRUCTIVE OBSERVATION OF TEST VEHICLES

Each test vehicle was divided into areas of interest. At each area of interest, the test vehicle was examined and given a numerical value according to the level of corrosion for each area of interest. Table 7.4.1 describes the rating point system and Table 7.4.2 and Figure 7.4.1 illustrate the areas of interest for non-destructive inspection.

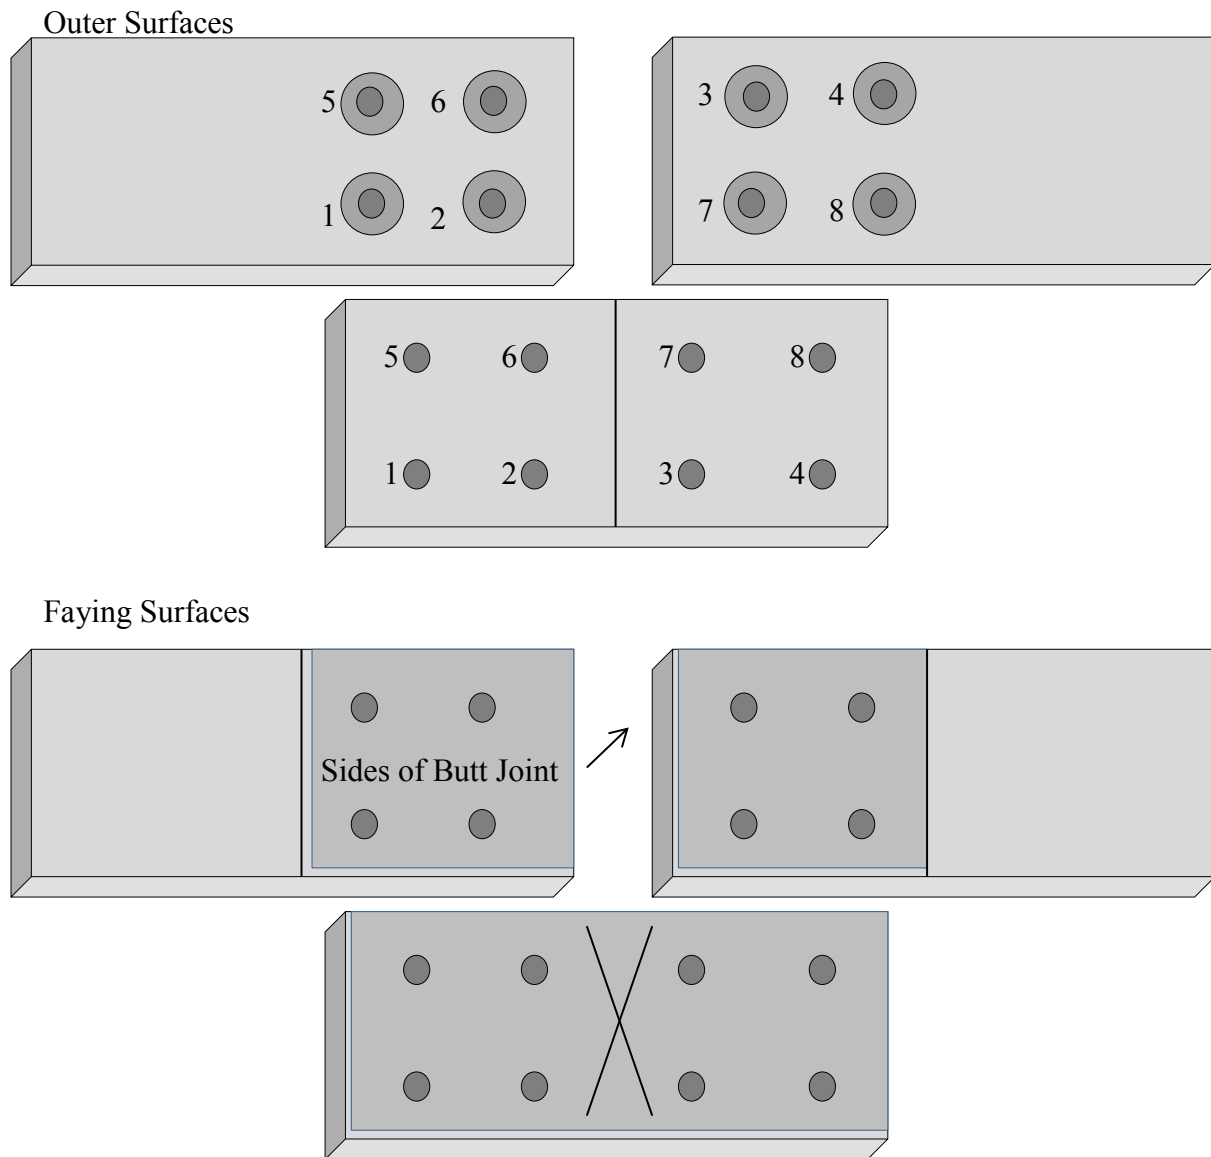
FIGURE 7.6.1 AREAS OF INTEREST FOR DESTRUCTIVE
OBSERVATION OF TEST VEHICLES

After deconstruction, the test vehicle parts were returned to Lockheed Martin for destructive inspection. The now exposed inner surfaces were divided into areas of interest, and a rating for the amount of corrosion in each area of interest was recorded. The ratings ranged from 0 – 100 percent area corroded; 0 representing no corrosion and 100 representing corrosion of the entire area of interest. Table 7.6.1 describes the three areas of interest and which parts of each area that will be examined. Figure 7.6.1 shows the location of each individual area to be inspected on a diagram of a deconstructed test vehicle.
