# **Lean Manufacturing Implementation at Food & Beverage Processing and Manufacturing Facilities**

December 2021

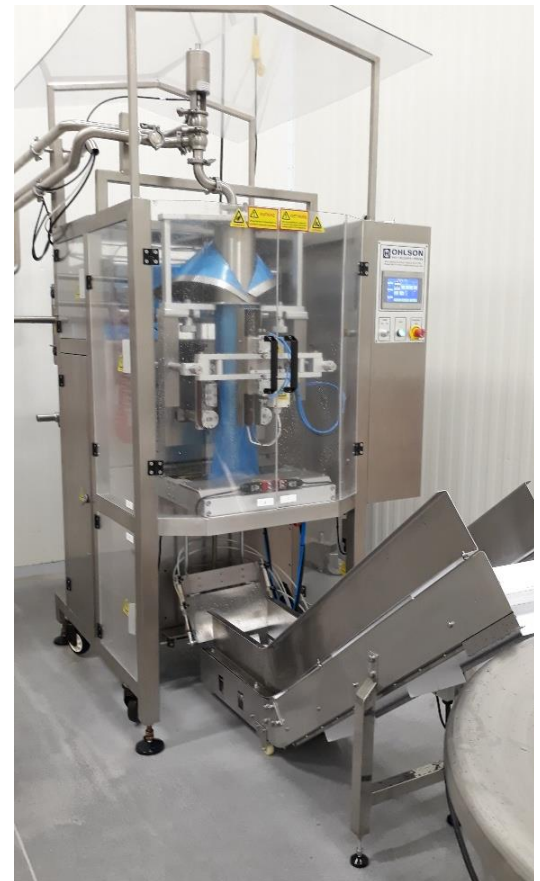
*Cedar's new bagging machine*

The in-house Engineering Department oversaw the installation of the new bagging machine using the thin film. The bag machine was installed in March 2021 and Cedar's ran a pilot study to fill some bags with toppings to run quality-control shelf-life studies. This step was completed with satisfactory results. The topping bagger was up and running in July of 2021.

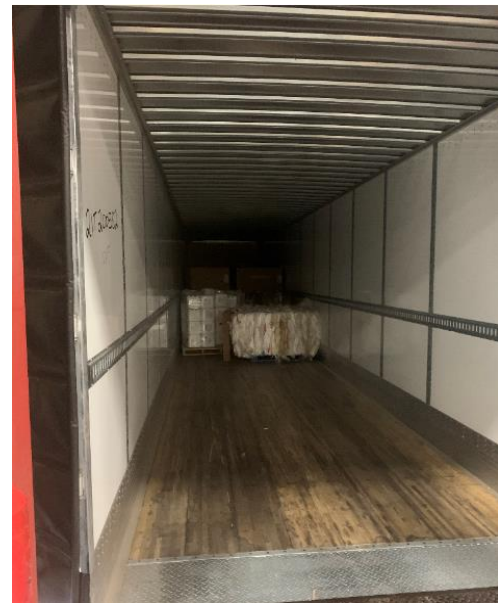
*Nearly empty tractor trailer*

Because the containers are empty, Coca-Cola is essentially shipping large volumes of air while attempting to recycle the drums and small containers used in the batching process. In addition, per internal requirements, employees must deface each container, which takes time away from production.

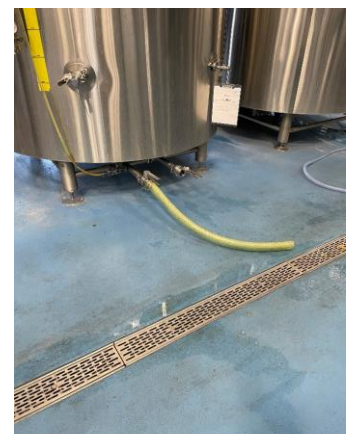
*Tank discharge pipe to drain*

The facility decided to pipe the tanks that are furthest from the drain so that they empty closer to the drain and do not contaminate the floor. This means that the floor does not get as dirty and therefore needs less cleaning. True North plans to continue to push conservation and solicit solutions from staff on how to conserve water throughout the cellar and maintain a sanitary facility in the process.

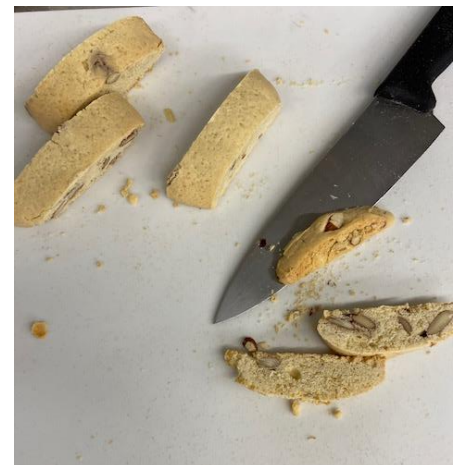
*Biscotti ends*

To try to eliminate the biscotti ends from being discarded, the production process was evaluated and it was determined that there were no changes to the process that would eliminate the waste. The biscotti dough is extruded onto a tray for baking, and the ends that are cut off do not make weight needed for sale and do not meet the visual standards of having cuts on both sides of the biscotti.

Therefore, the company researched other uses for the biscotti ends, hoping they could be consumed instead of wasted. For some time, they sent the biscotti ends to nearby animal farms to be used as animal food. They then connected with Lovin' Spoonfuls, an organization which rescues food, and together they created a program called "Odds and Ends," in which Bisousweet would bag the biscotti ends and give to them to Lovin' Spoonfuls to distribute to food pantries, shelters, and other charity organizations. Unfortunately, with the combination of COVID-19, high demand for product, and staff shortages, the program has not officially launched. Bisousweet also looked into a program in Boxboro called "Freebie Market," which gives out extra food to those in need for free. They have been collecting bags of their biscotti ends and giving them to the Freebie Market for distribution. However, Collins does want to revisit and launch the Odds and Ends program once the company is situated in Leominster.

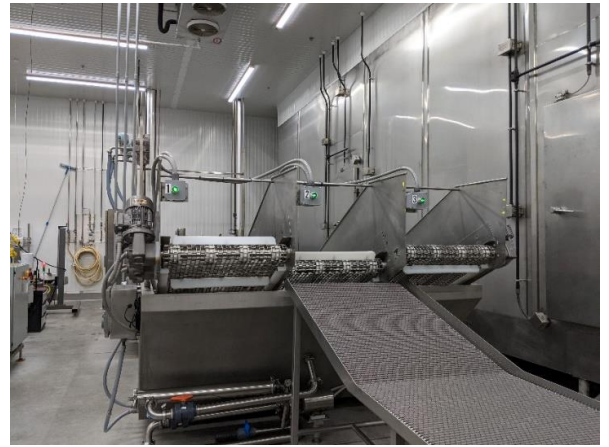
*Conveyor off of three lane chiller*

The quality control and maintenance teams at Plenus have implemented the Lean tools to help reduce water being wasted at the facility. The quality control team first initiated the idea of a skirting system for the conveyor belt coming out of the chiller to keep the bags from being snagged. However, the maintenance team did not think the skirting system would work. They then proposed the idea of lowering the angle on the conveyor belt so that bags would more easily drop off the conveyor and not get snagged underneath.

The change in the chiller conveyor belt angle was immediately implemented and resulted in an 80-90% reduction in ripped bags.
